Tracy Lewis House
35 Wolfe Avenue
Beacon Falls, Connecticut

Conditions Assessment
&
Reuse Study

May 10, 2010

PAUL B. BAILEY
• ARCHITECT •

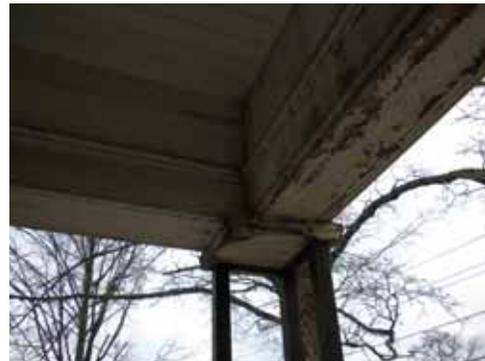
The Front Entry roof is supported by a decorative metal tri-post. These replaced the original columns whose remnants remain. It is recommended to remove the modern metal post and replace with columns matching the original design. For the most part grade is level or slopes slightly away from the residence. As previously mentioned, the existing landscaping around the perimeter of the structure has been removed. The rearyard consists of open area rising slightly to a mature

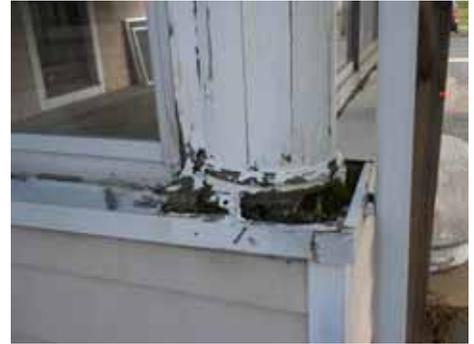
The sideyard has a Porte-Cochere which is in a deteriorated condition. The columns are failing and have been reinforced with temporary posts. All need to be replaced with new matching columns. Adjacent is a nice open space, which is part of the property, with a mature fir tree. The property is flat and maintained. The tree will be removed to allow expanded use of the parcel.

- 3) Remove Porte-Cochere and Side Porch structure. Replace with new Porch on a new foundation and new Porte-Cochere with columns.
- 4) Excavate around the perimeter of the entire foundation and repair as required. Install new waterproofing on foundation. Add underground drainage system and connect all downspouts.

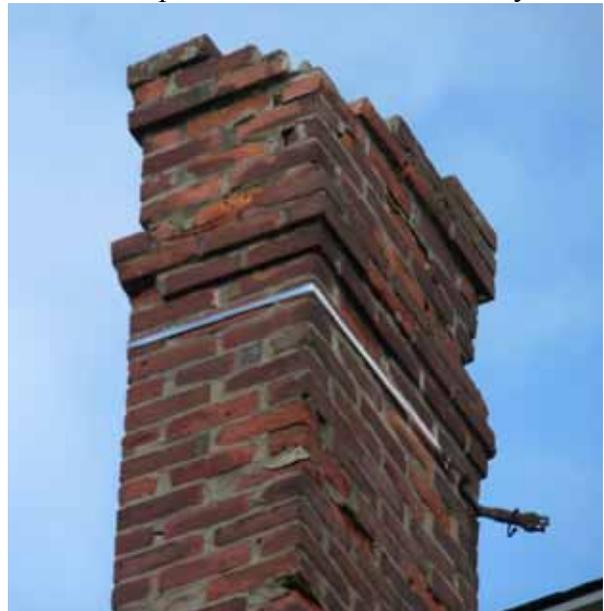
There are three brick chimneys. The Living Room chimney sits at the rear wall with exposure on three sides. It is corbelled to reduce size with no step covering. This creates exposure and sills which allow water to sit and penetrate into the chimney. Also sealant is required at the joint with the siding. Many brick and mortar joints are missing below the roof line. The chimney portion above the roof line is badly deteriorated to the point of collapse. The condition is causing water damage on the interior. The chimney should be removed and replaced. The second chimney vents the second floor fireplace adjacent to the porch access. There is no visible sign of support for this fireplace and chimney on the first floor or in the basement. The exposed portion of this chimney is missing many bricks and mortar. It too is worn and deteriorated and needs to be removed, replaced or possibly re-supported. The chimney housing the boiler flue appears in better condition but it holds no architecturally aesthetic details or shapes. It is suggested to remove this chimney as well to free up some interior space and design of the exterior. A new boiler can be vented without need of a chimney. In short all chimneys are past their useful life cycle and need to be eliminated or replaced.

- 5) Remove all three chimneys. Replace only Living Room chimney.
- 6) All existing windows and doors should be either replaced or retrofitted by Bi-Glass. The existing openings can be reused. If new windows, they will make the existing architecturally muntin design as well as trim design. They will also be energy

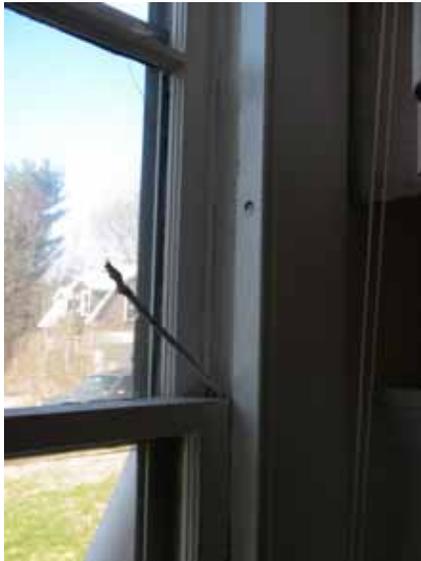
The windows appear to be the original single pane wood units. Storm windows were added on the exterior. The exterior trim has been covered during the aluminum siding installation. The sashes are not in good shape. All need new puttying, scraping and painting. The windows are hard to operate with 80% not operating at all as their weight and pulley system is broken. The storm/screen windows are hard to operate or do not work at all.

The windows should be replaced or fixed. This can be accomplished in two ways. The first is total replacement of the windows with modern energy efficient units. These can replicate the size, design and trim of the original. With insulating glass there is no need for storm windows. The second option is a procedure from Bi-Glass. The sashes are scraped; gashes and defects filled in and prepped for painting. Bi-Glass reglazes the existing sashes with double paned thermal argon gas filled glass panels, cut the muntins in half and reapplies them to both side of the window in a matching pattern. Then the window is rebalanced and reinstalled.

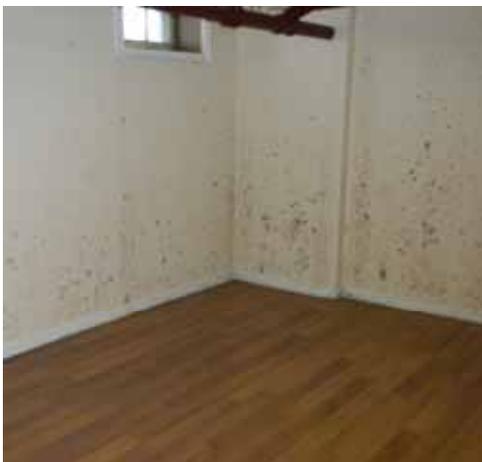
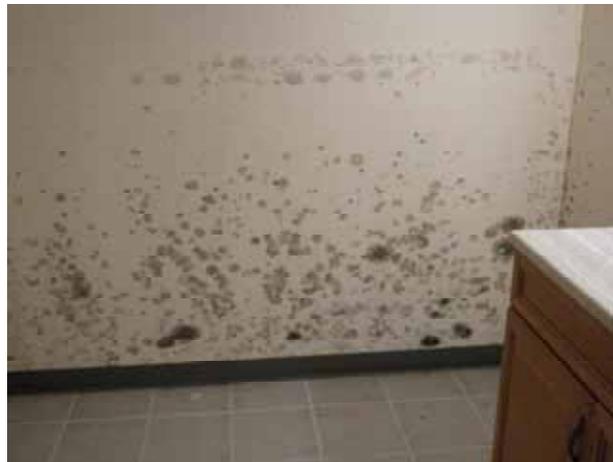
The Basement is under the entire footprint of the building. The basement stair leads from the Kitchen and is not up to today's code requirements. A new location will be required for new stairs. The stairs lead to a finished portion including an open Playroom/Family Room separated by a column line, Powder Room and Laundry. This finished portion has a suspended acoustic ceiling on a grid. The walls are furred out with wood studs and gypsum board finish. The columns are also furred and finished. The entire finished area is infested with mold, requiring removal and remediation.

All finishes should all be removed and discarded. The dampness is probably caused by moisture penetrating the rubble stone foundation walls and the lack of a dehumidifying system. The foundation wall is solid brick above grade and solid stone below grade. A de-humidifying system will need to be installed and it is recommended that a spray-on rubberized waterproofing be installed on the exterior of the stone portion of the foundation.

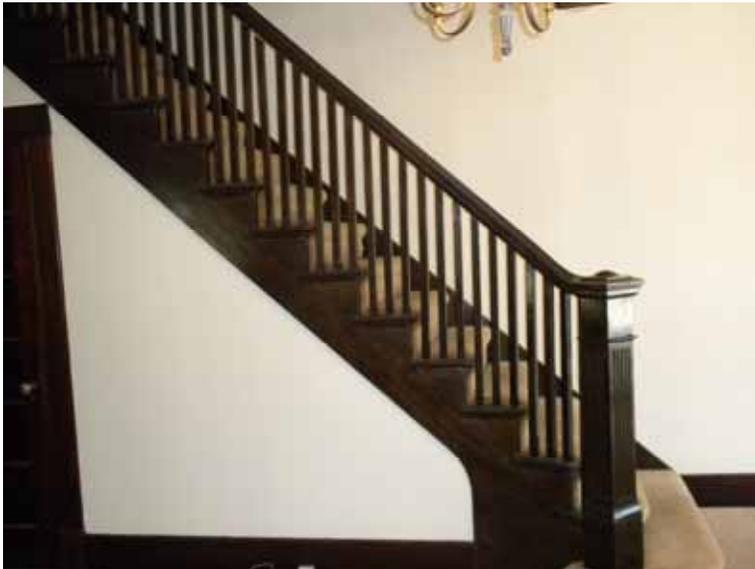
throughout are plaster with many cracks. The ceiling has a popcorn finish, possibly to hide the plaster cracks. Ceiling moulding is a three inch flat trim, possibly added after ceiling covering. The floor is carpet over original strip oak sloping toward the center of the house. The base trim is 1"x 7" flat. Casings are 1"x 5" flat with 6" wide head trim at doors and windows. In general, the trim design is simple, mostly flat, stained a dark color. This style is continued throughout the house.

Throughout the First Floor the walls and ceilings are badly cracked in need of removal. The amount of cracking probably indicates a structural support issue near the center of the house. It is recommended to remove all the plaster from the walls and ceilings, correct the structural issues and install new gypsum board finish.

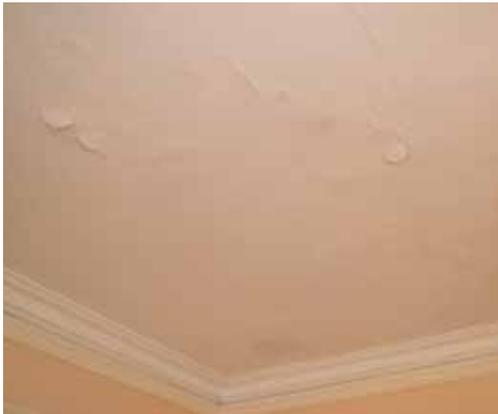
The Dining Room ceiling is badly damaged showing water damage. The walls and strip oak floor are also water damaged indicating a severe water leak at one time. There is no further evidence of more recent leaks. The floor slopes toward the Kitchen.

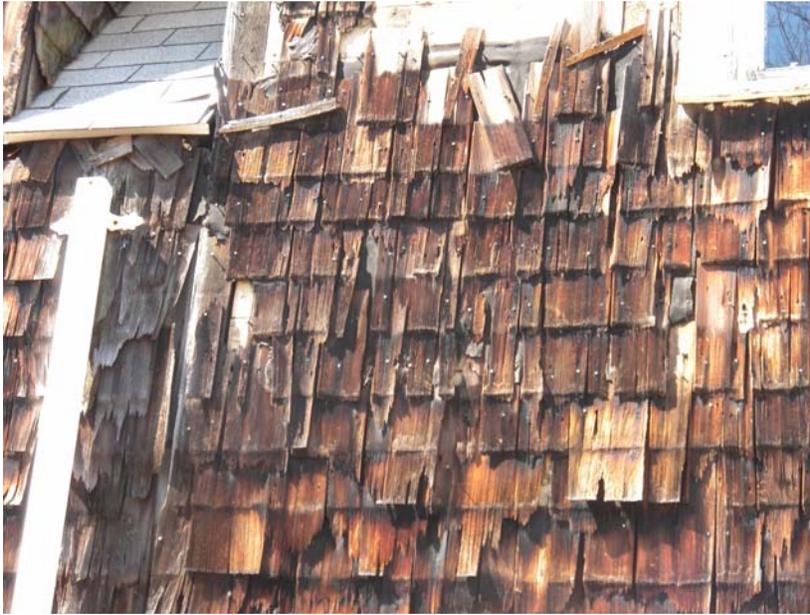
The siding is wood shingles. Most of the siding is beyond its life cycle with a large portion of the siding gone. The remaining siding does come in contact with the ground causing water and pest damage. All siding and sheathing needs to be replaced. The majority of trim moulding is also rotted and in need of replacement. One exterior wall is bowed. This needs to be corrected. There are numerous holes in the

siding which would be remedied by replacement of the siding and sheathing.

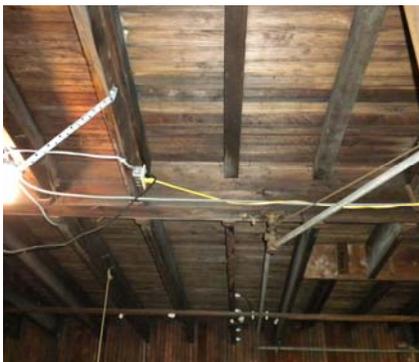
The Lower Level is presently used as a garage for storing Town equipment. The existing floor is slab on grade pitched toward a drain. The slab is cracked and should be removed and replaced with an insulated

reinforced concrete slab. There is no interior wall finish and insulation. Overhead door tracks were installed by cutting into the header beam. This beam needs to be replaced. The floor construction above is open as there is no ceiling finish. Fire rated gypsum board and insulation is required. The main support beam runs side to side and is bowing in the middle. Posting or replacement is

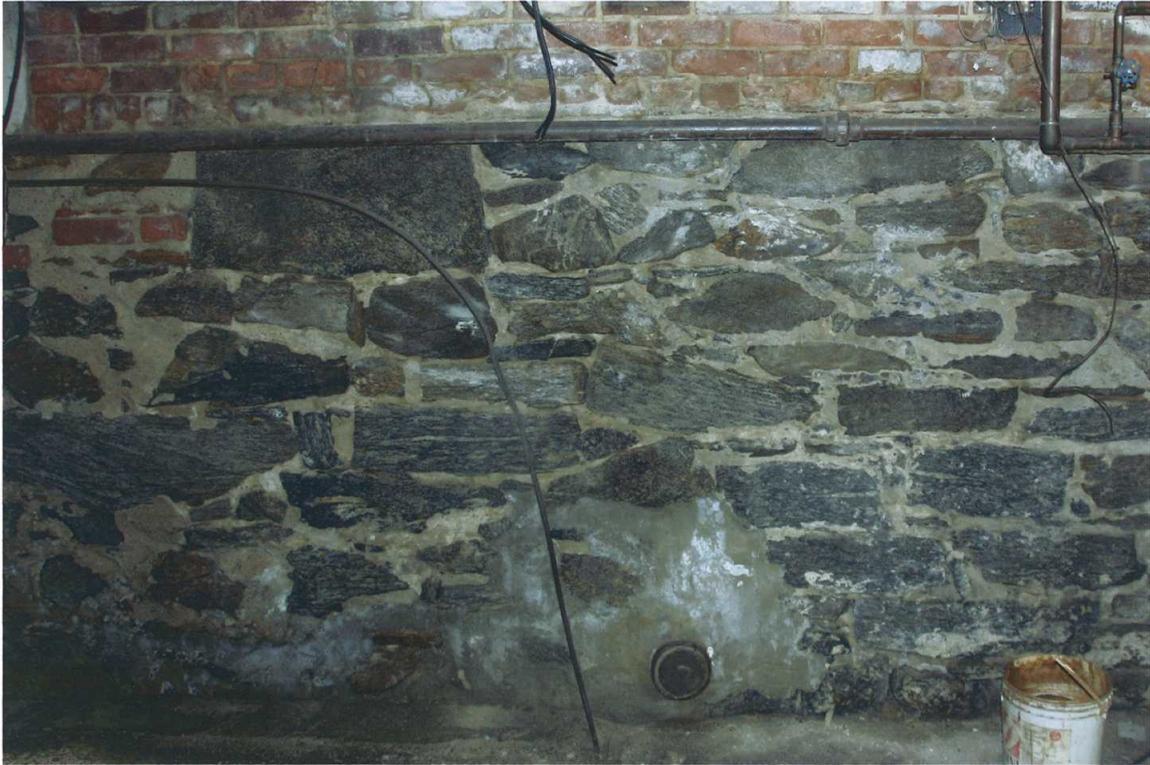
1. Typical foundation wall interior - rubble stone below grade, brick above. Good condition.

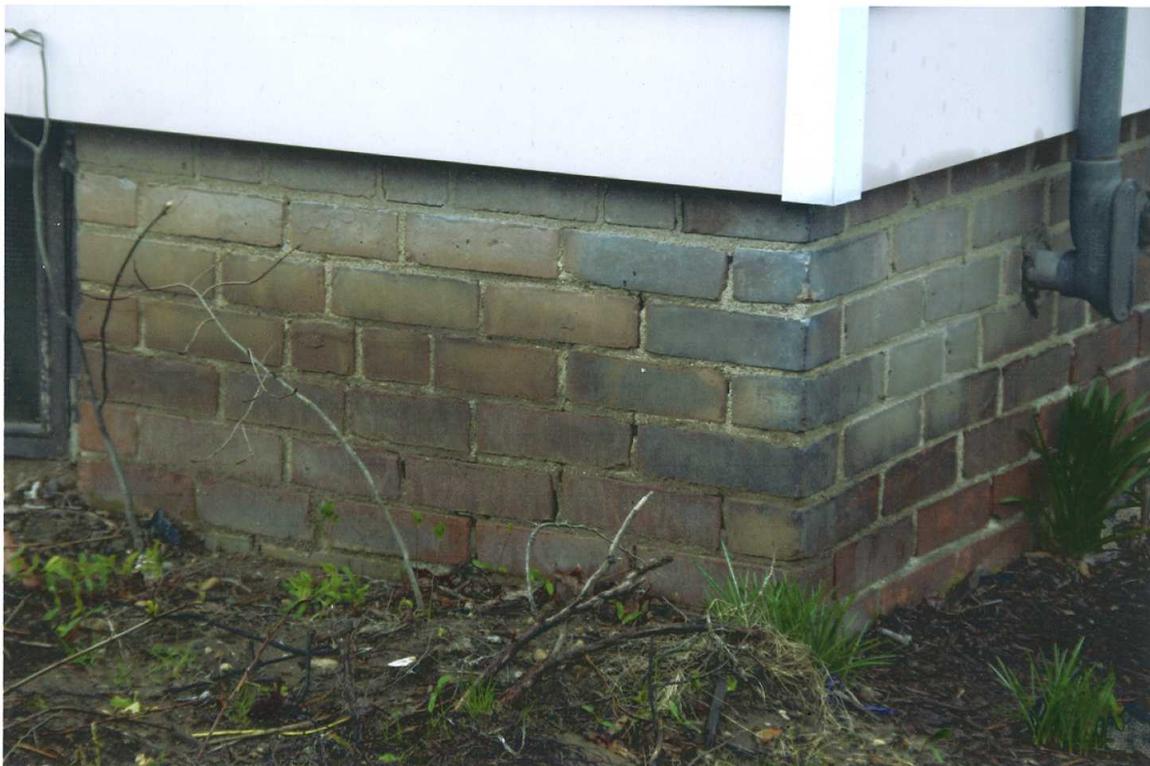
2. Exterior of brick foundation wall. Good condition, minor localized pointing needed.

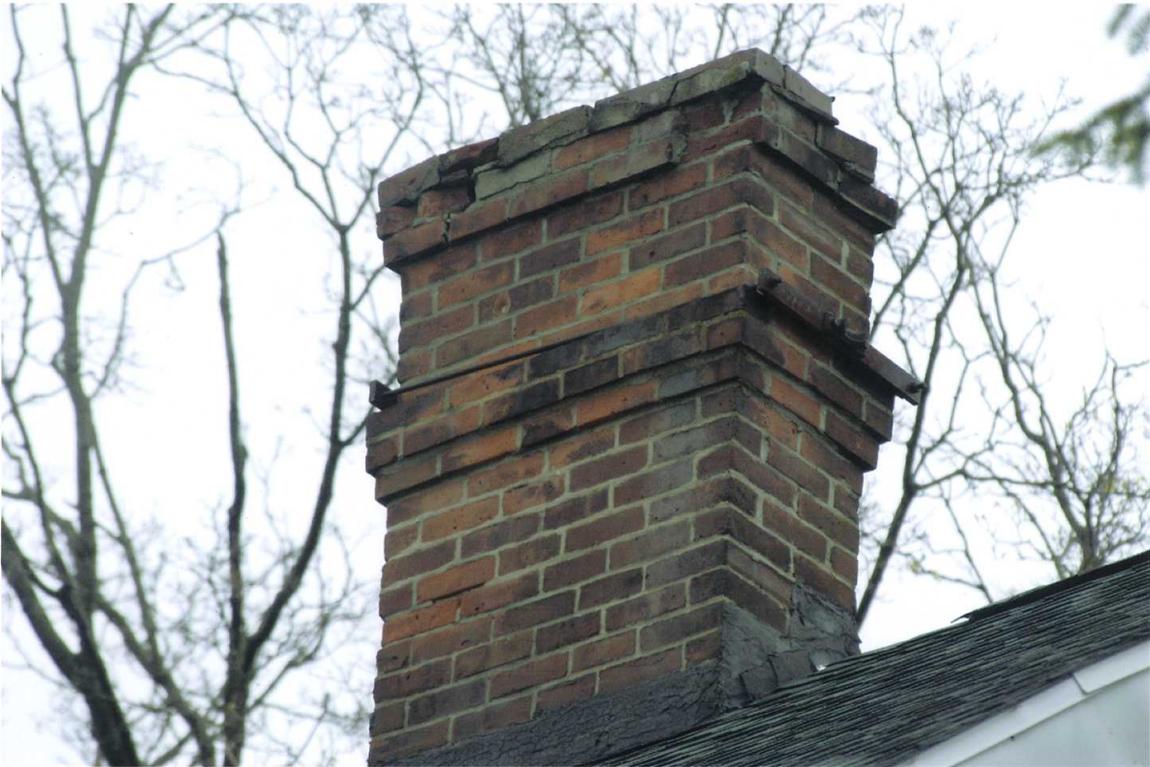
3. Main chimney in poor condition at top. Repairs needed.

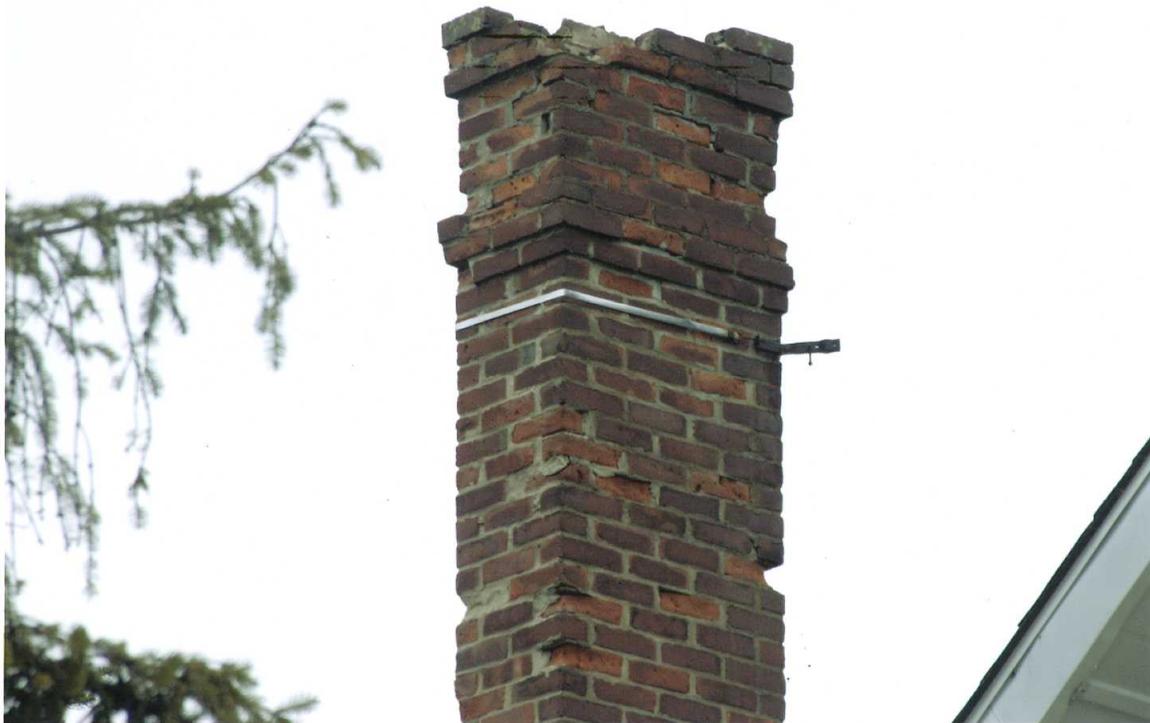
4. Rear chimney coming apart at the top, spalling bricks. Needs repairs.

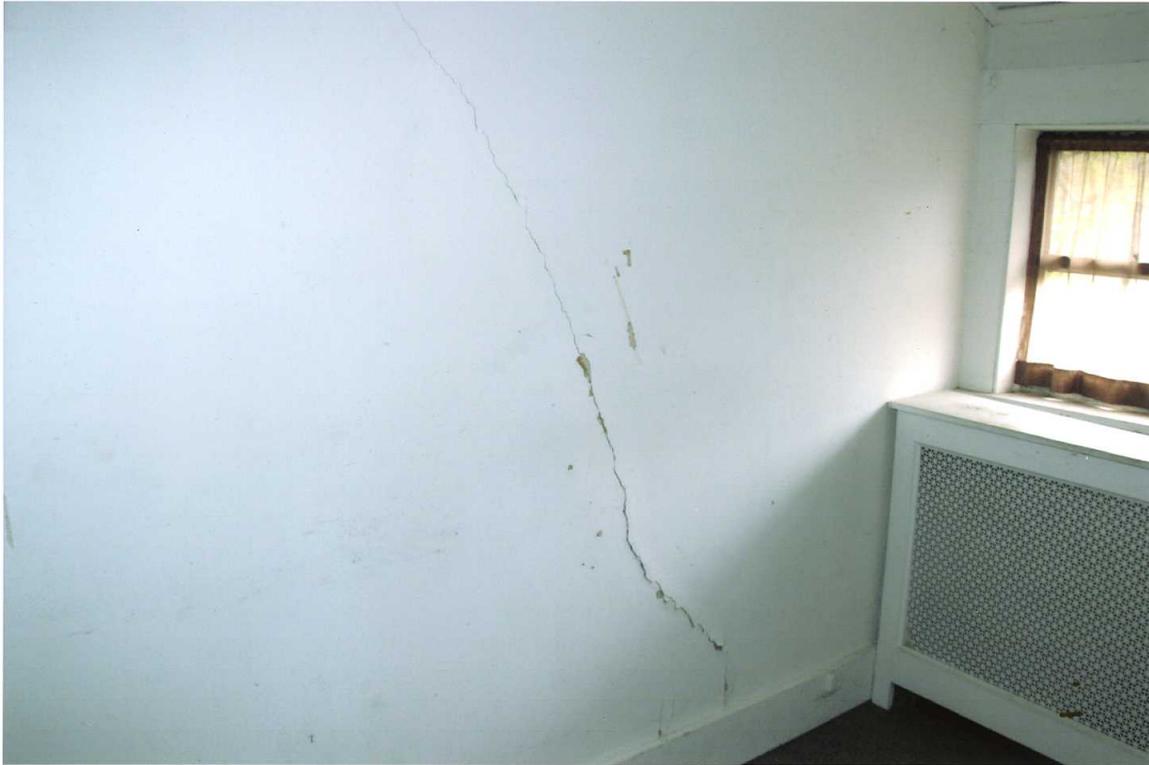
5. Typical diagonal cracking of interior walls. Direction indicates settlement of house interior.

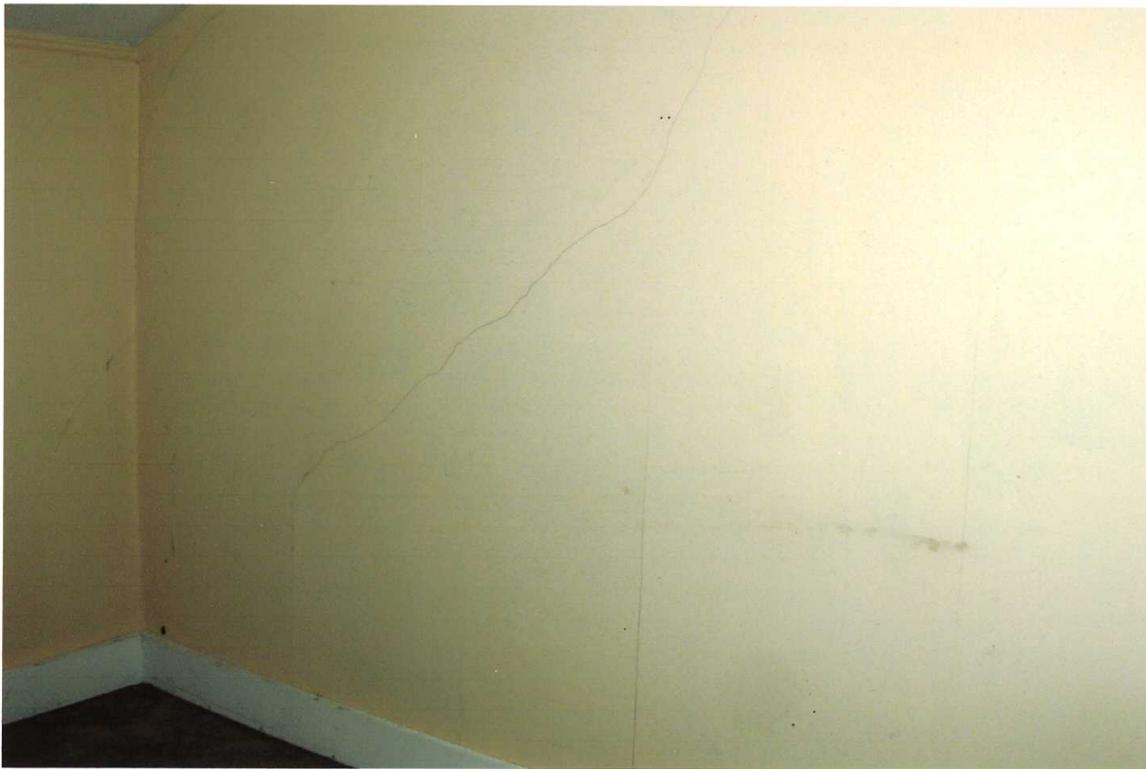
6. Another example of diagonal cracking indicating interior settlement.

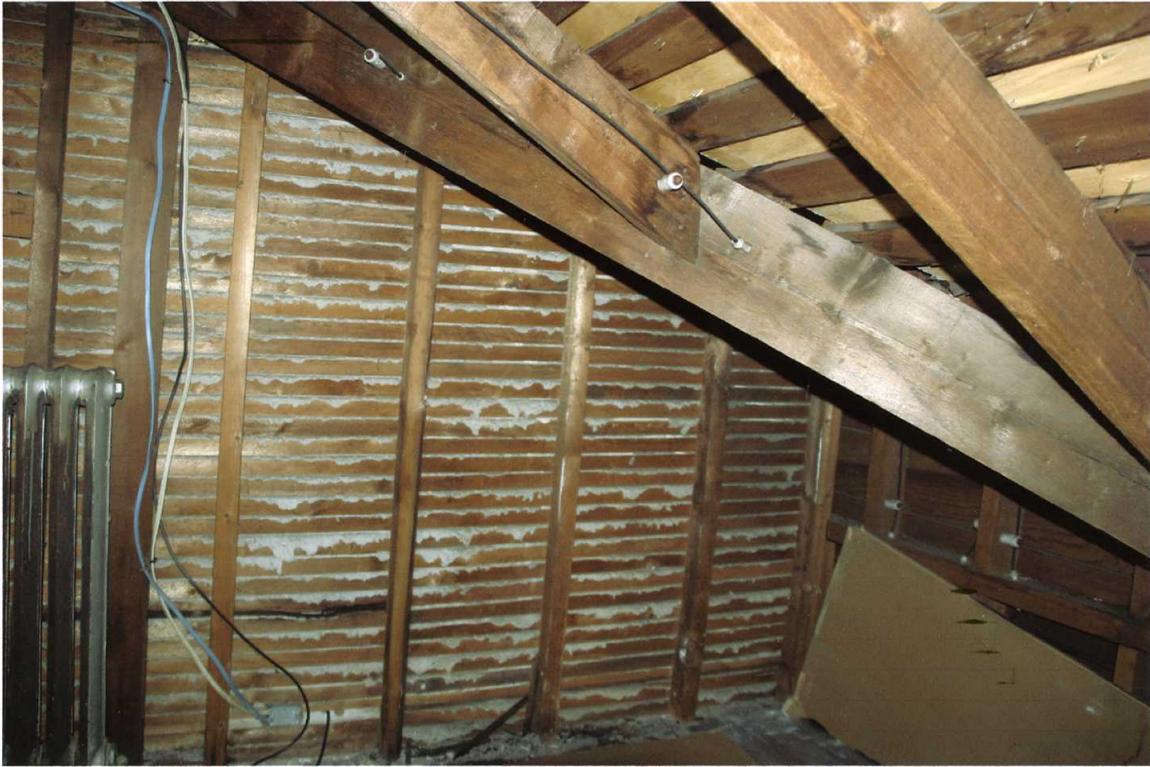
7. Typical roof and wall construction. Plywood added over spaced roofing boards.

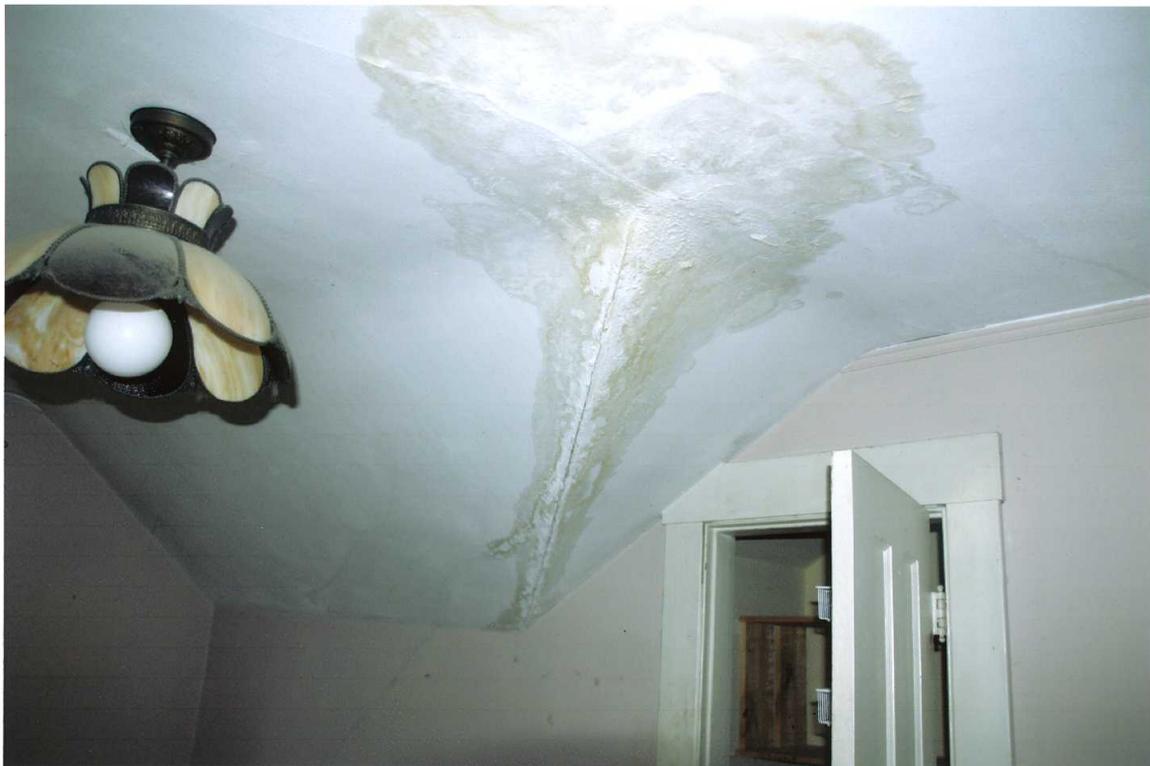
8. Stains from roof leaks in roof valley. Plaster still sound.

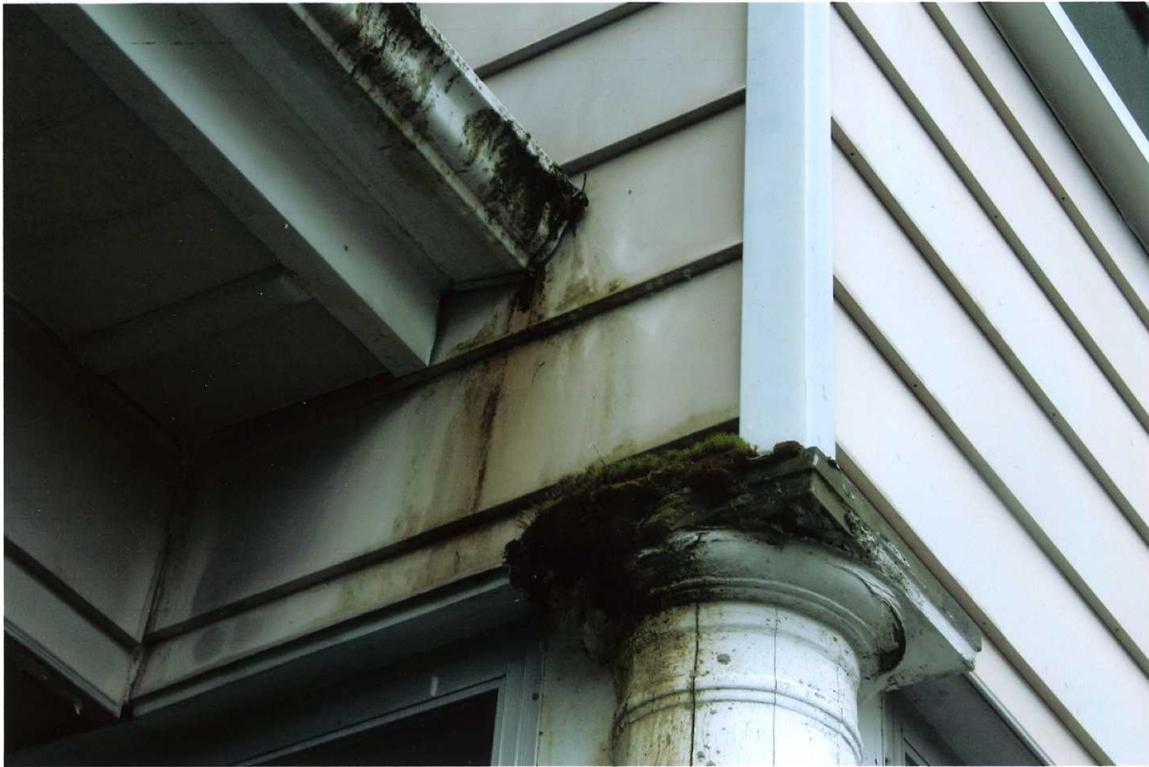
9. Rotting and mold growth at top of corner column on left wing of house.

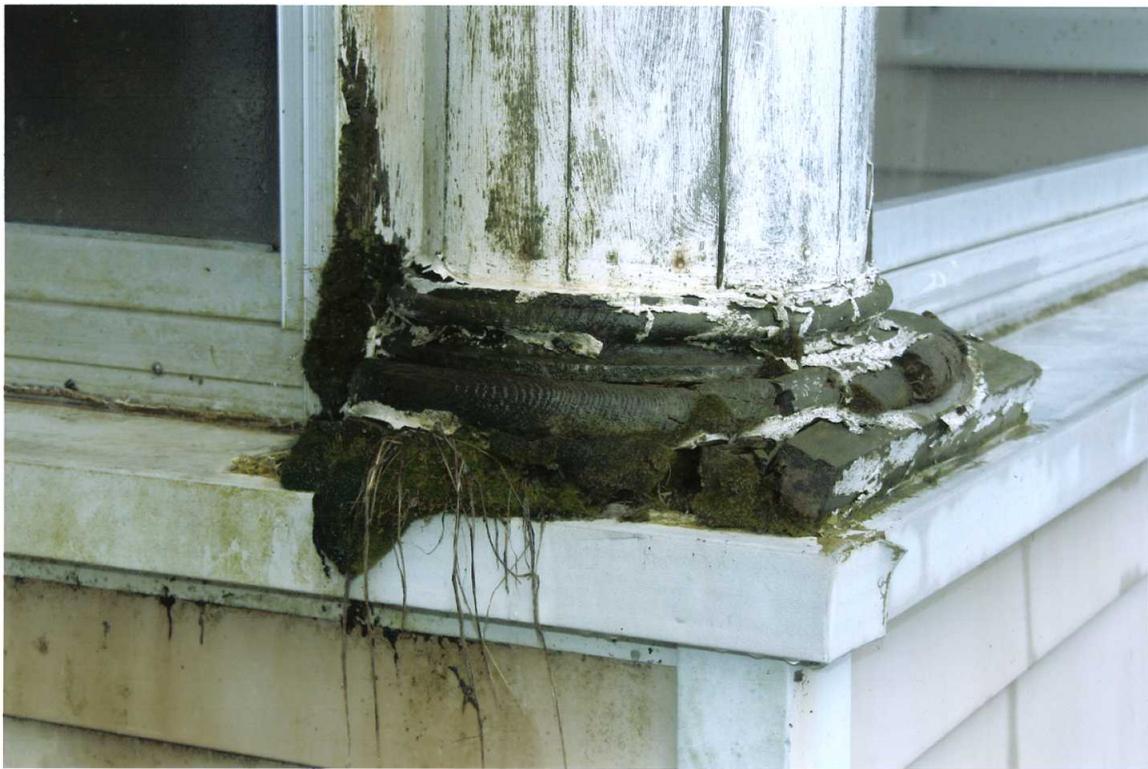
10. Rotting and mold growth at bottom of same column.

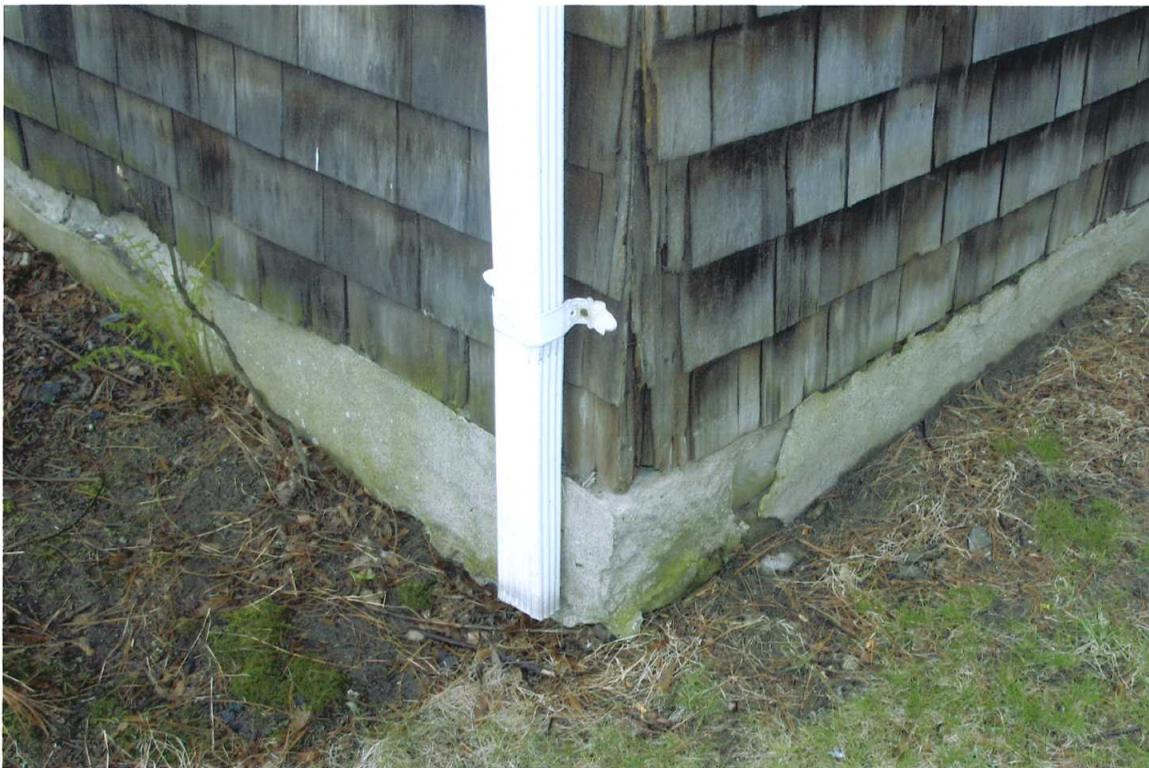
12. Mortar spalling from foundation at right rear corner of Carriage House.

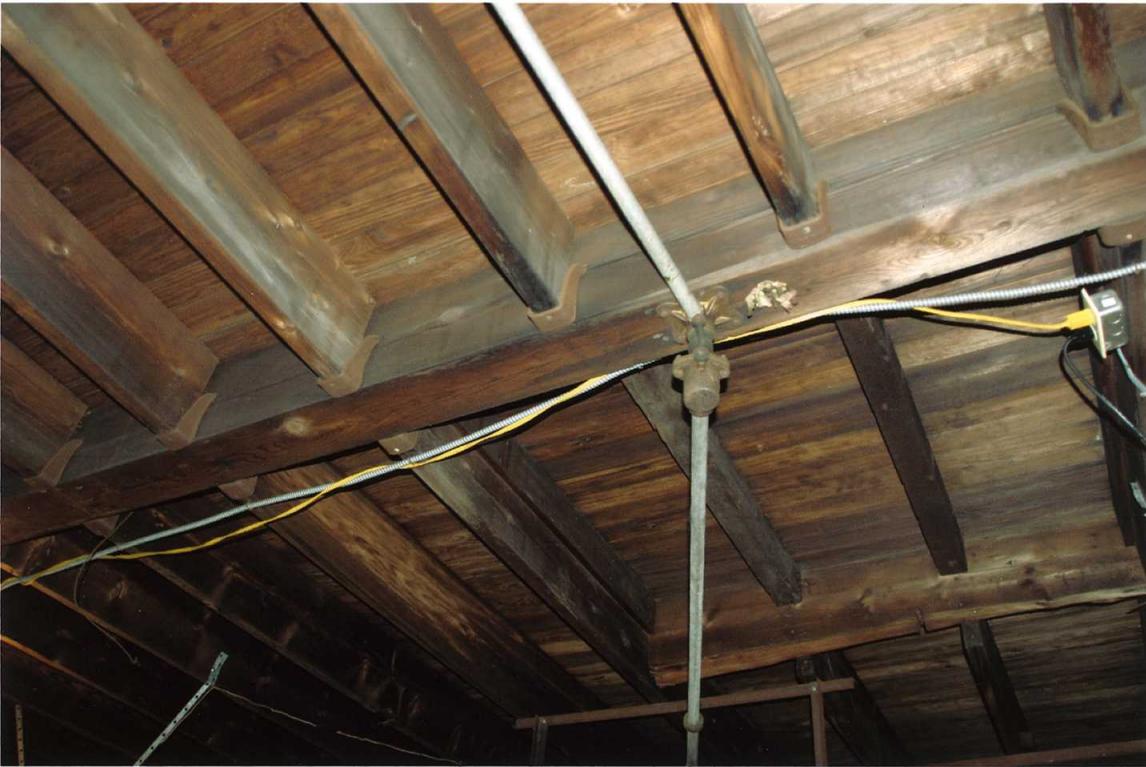
13. Deflected beam in second floor of Carriage House.
