Lantern Ridge Open Space

Beacon Falls, Connecticut

Environmental Review Report

Report #355

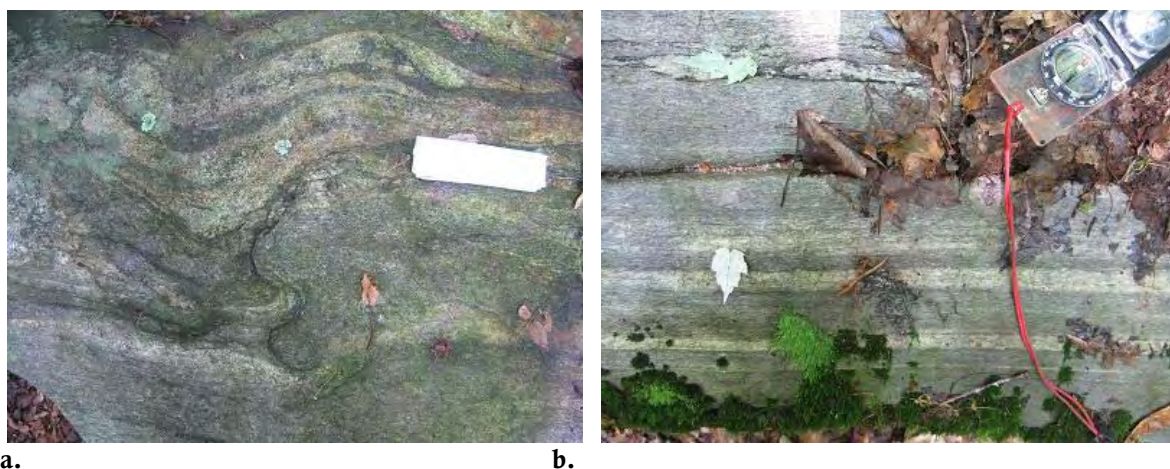
Figure 2. Rocks from the south-eastern part of the parcel are mapped as Golden Hill Schist. They, however are more gneissic than schistose. White area in a. is folded piece of 8.5x11 piece of paper. Its dimension parallel to the bottom of the image is 8.5". Compass in b. is 2.5" wide.

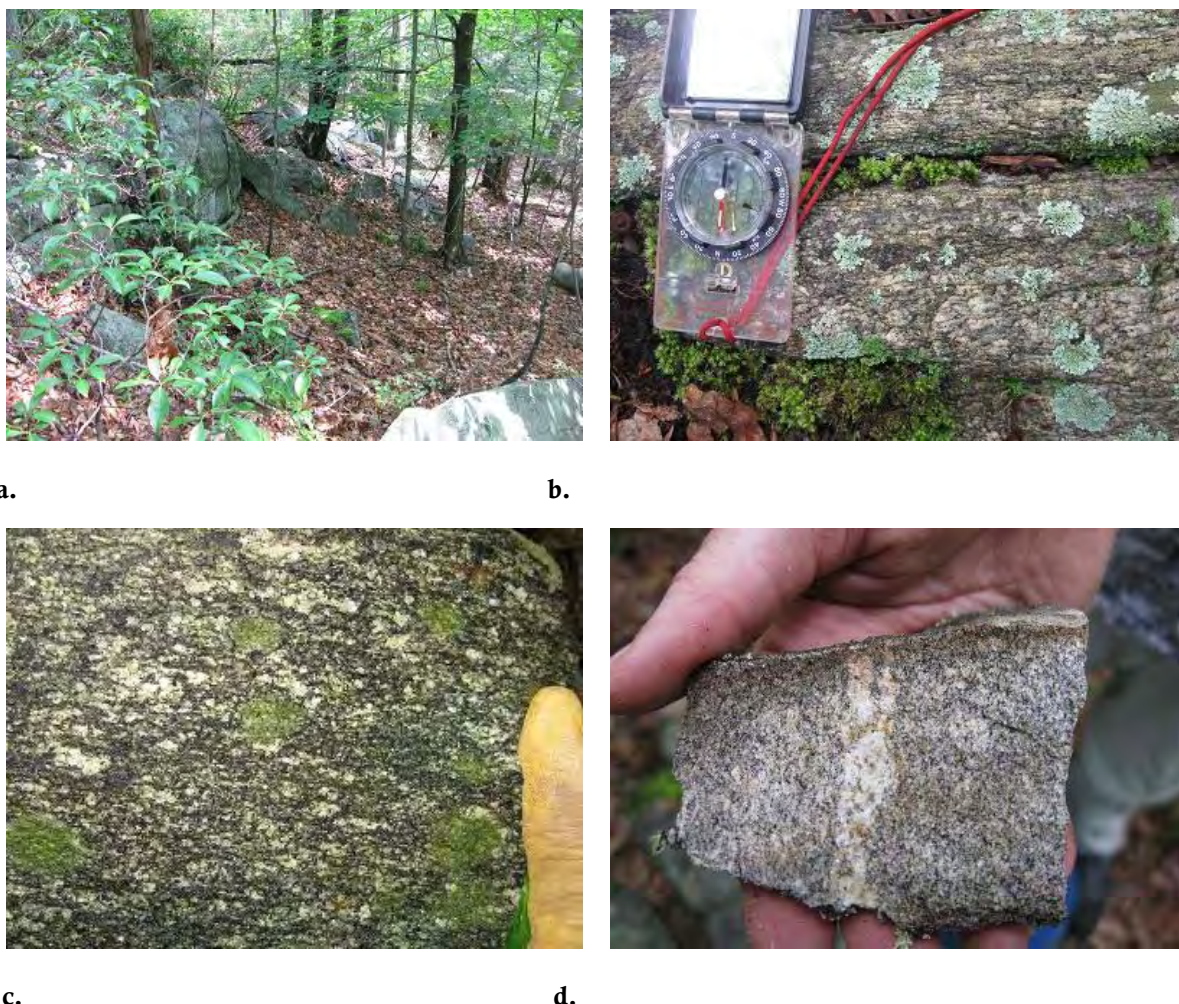
Figure 3. a. Typical outcrops of the Beardsley Member of the Harrison Gneiss on the knobs in the central portion of the parcel. Moderate slopes are capped by abrupt east facing ledge that may be as much as 5 feet high. Outcrops on top of the knob are low and discontinuous. No outcrops were found on the steep west facing slope. The rock has an overall grey appearance. **b.** Typical Beardsley Member gneiss. (Compass is 2.5" wide). **c.** Porphyroblastic gneiss of the Beardsley Member (little finger of glove at right is about $\frac{3}{4}$ " wide). **d.** Local feldspathic veins cut the Beardsley Member.

The Beardsly Member of the Harrison Gneiss (Ohb) forms moderate sized outcrops on the two knobs in the center of the parcel (Figure 3a). It consists of foliated granitic gneiss composed of plagioclase feldspar and lesser amounts of quartz (Figure 3b). In some areas the feldspar forms elongate porphyroblasts² that parallel the foliation (Figure 3c). Biotite is a minor constituent. The resulting rock is light to moderate gray and poorly banded. In places thin veins filled with plagioclase feldspar and quartz cut the gneiss (Figure 3d).

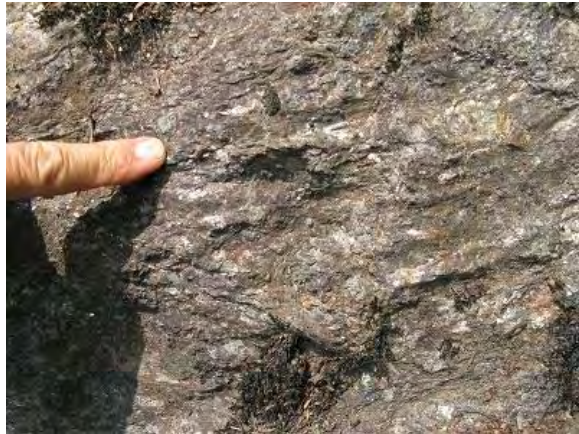
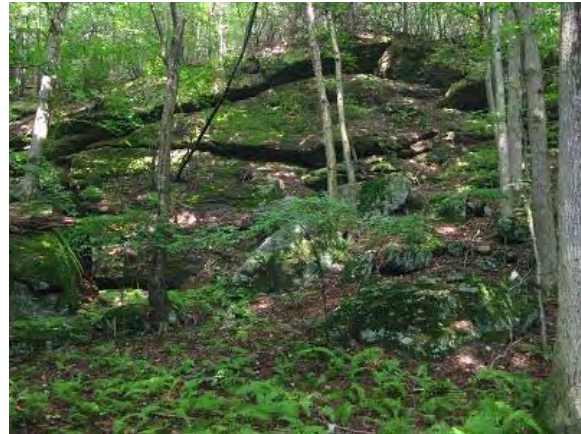
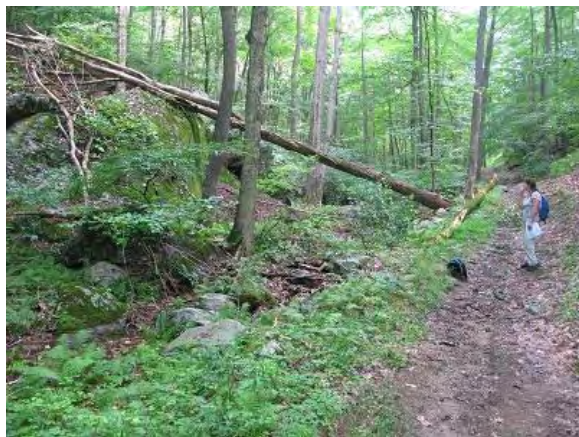
Figure 4. a. The Straits Schist consists of brown-weathering, garnet bearing muscovite schist. b. East facing cliffs of Straits Schist exposed near the col between Rimmon Brook and North Rimmon Brook. c. Deep, steep-sided valley near the headwaters of south-flowing Rimmon Brook. Straits schist is exposed on left. Alluvium in bottom of valley has covered a diabase dike.

The schist is a brown-weathering biotite-bearing quartz muscovite schist (Figure 4a). Some layers contain plentiful garnets. According to Rodgers, it was in fault contact with the metamorphic rocks to the east of Rimmon Brook. The fault apparently weakened the rock allowing glacial erosional-processes to carve a steep-walled valley (Figure 4b). Later, during the early Jurassic, basaltic-magma intruded along the fault-plane (Figure 4c).

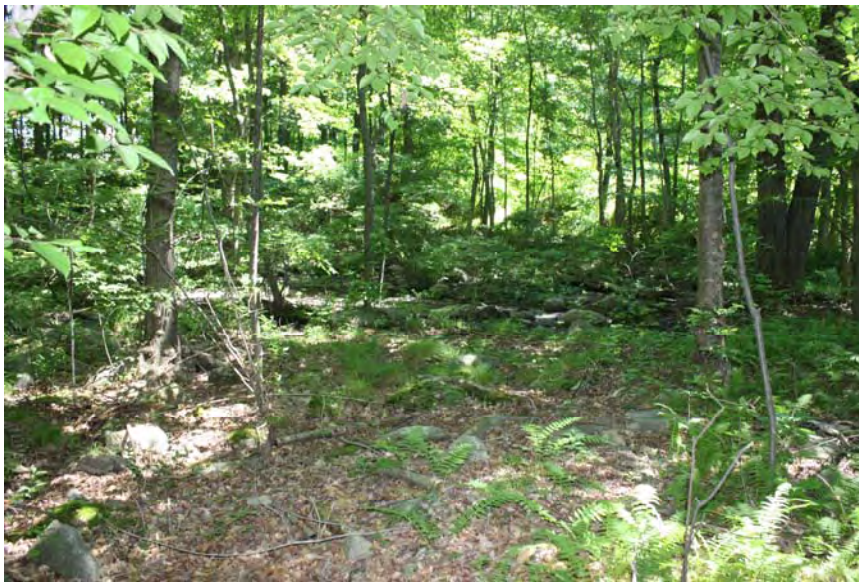
Parking Area

Redesign - This soil type abuts the current parking area off of Skokarat Road, which needs to be redesigned, provide adequate buffering (35' min) from the parking area. Consideration of a potential access route for maintenance and EMS responses into the parcel from this

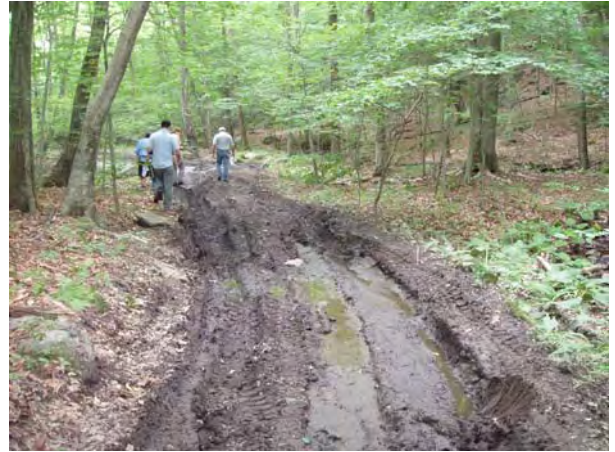
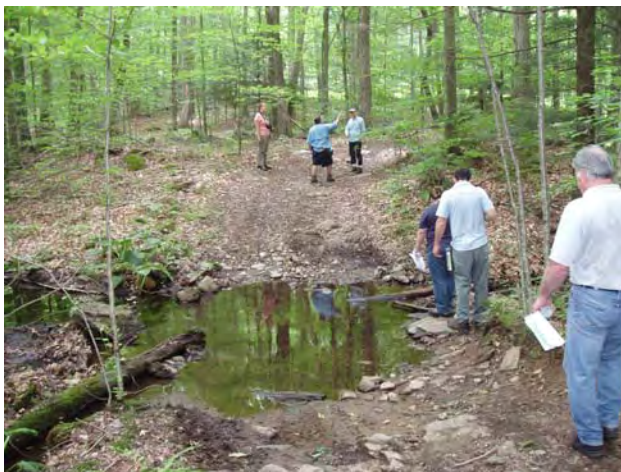
Vehicles driving in the vicinity of North Rimmons Brook on the woods road and old logging roads with some off- road travel are creating erosion problems where tires have churned the soil. Vehicle tires bring in weed seeds. The invasive Japanese Stilt Grass grows in places on the dry road shoulder as well as in moist places along the road and in the adjacent stream flat. If the recreation goal for the property does not include vehicle use, then working with abutting landowners to control vehicular access to the property would be advised to prevent the movement of roadside Japanese Stilt Grass onto and within the property (as well as to prevent further soil and water quality degradation).
