Tracy Lewis House
35 Wolfe Avenue
Beacon Falls, Connecticut

Conditions Assessment
&
Reuse Study

May 10, 2010

PAUL B. BAILEY
• ARCHITECT •

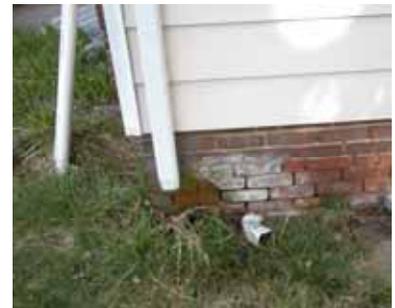
Gutters are aluminum and ogee in design. The downspouts daylight the rain water at grade. The original downspouts ended at cast iron boots which drained the water into the basement and the storm water drainage system. It is recommended to abandon this and that any new gutters drain to a new storm drainage system below grade. The

new gutters should be of period design.

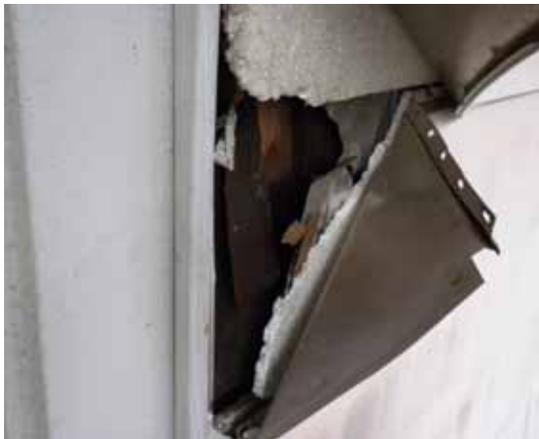
The existing siding is aluminum with aluminum trim. The original siding was wood shingle with wood trim. This is still evident at points under the aluminum and also revealed at Porches. The aluminum siding should be removed. Since the aluminum siding has been installed for many years it is a safe assumption that all of the original siding and trim will need to be removed. The overhangs also have aluminum covering. The overhangs are ample in size, approximately 22". This provides great shadow lines and shade. Once the covering is

removed the moulding can be returned to original condition.

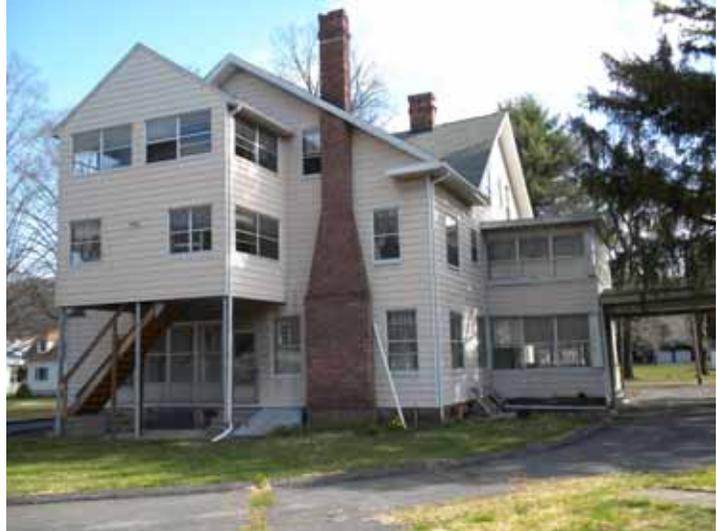
This addition houses the second means of egress from the Second and Third floors. The ceiling is plywood with wood floor. The walls are paneled and bowing. The stairs are in good shape but the structural posts are rusting and need replacing. This addition does not mimic the original design detail of the existing house. It should be replaced with a structure complementing the original house.

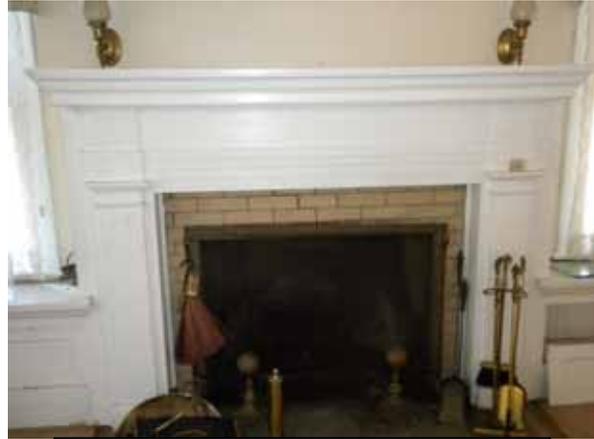
Living Room fireplace mantel

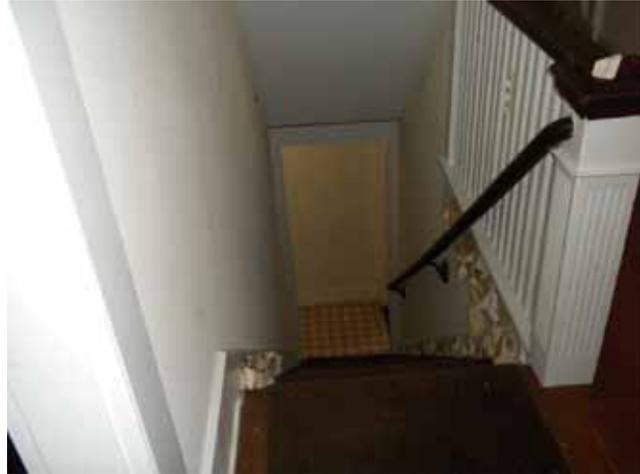
The formal access to the Second Floor is the front staircase. A second stair, at the rear, also provides access. The Exterior Stair Addition also provides access. The formal stair is in good shape but the railing is low and needs replacement. The balusters and railing match the First Floor detail. Since this stair is not enclosed with a fire rated enclosure, it does not meet the requirements as a means of access.

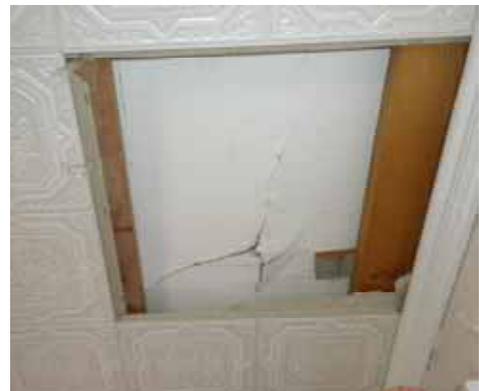
There is a small fireplace with no visible means of support. It may be supported by the First Floor wall below. The Porch itself has roll roofing floor with aluminum window enclosure. These are not in keeping with the architectural time line and need to be removed. The ceiling indicates water damage, probably due to original roof.

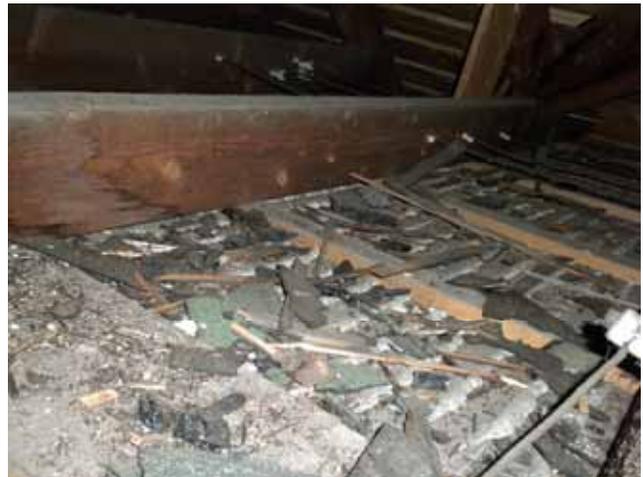
The attic is accessed through a panel in the closet ceiling of the front bedroom. The area is open, approximately 6' high. The roof structure is exposed indicating 2x6 rafters supporting wood furring, from original wood roof, plywood sheathing and new asphalt shingles. The ridge beam is one piece of decking, typical of a house this age. The ceiling joists are 2x6. The attic is filled with construction debris from the roof replacement project. There is no attic insulation.

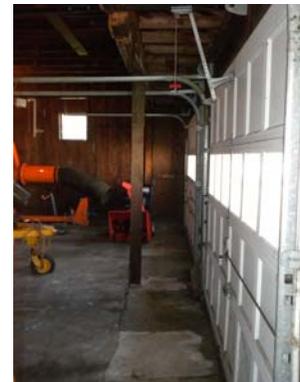
reinforced concrete slab. There is no interior wall finish and insulation. Overhead door tracks were installed by cutting into the header beam. This beam needs to be replaced. The floor construction above is open as there is no ceiling finish. Fire rated gypsum board and insulation is required. The main support beam runs side to side and is bowing in the middle. Posting or replacement is

recommended. The stair to the upper level is small with no rail and runs directly from the slab to the floor above. It is not steady and needs to be replaced. There is no mechanical system.

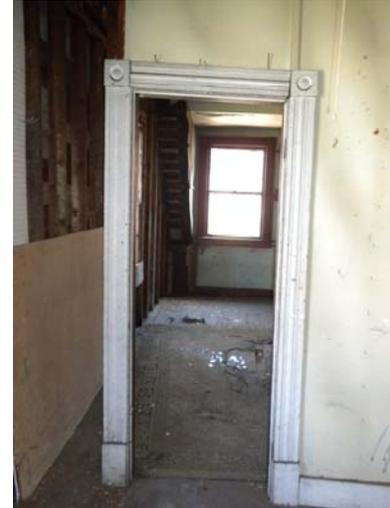
The Upper Level is accessed from the stair described previously with no guard rail. The entire level has no finishes and no insulation. The floor slopes noticeably to the center corresponding with the beam note previous. The upper level has no mechanical system installed.

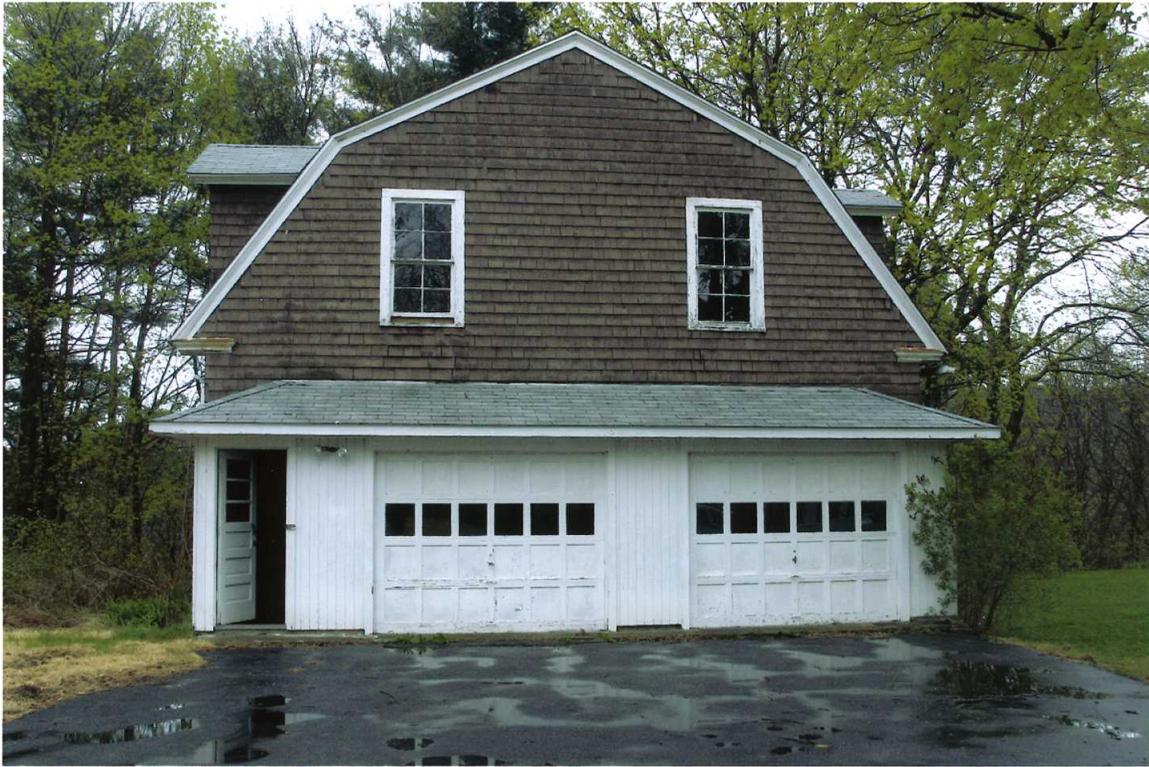
11. Front wall of Carriage House.

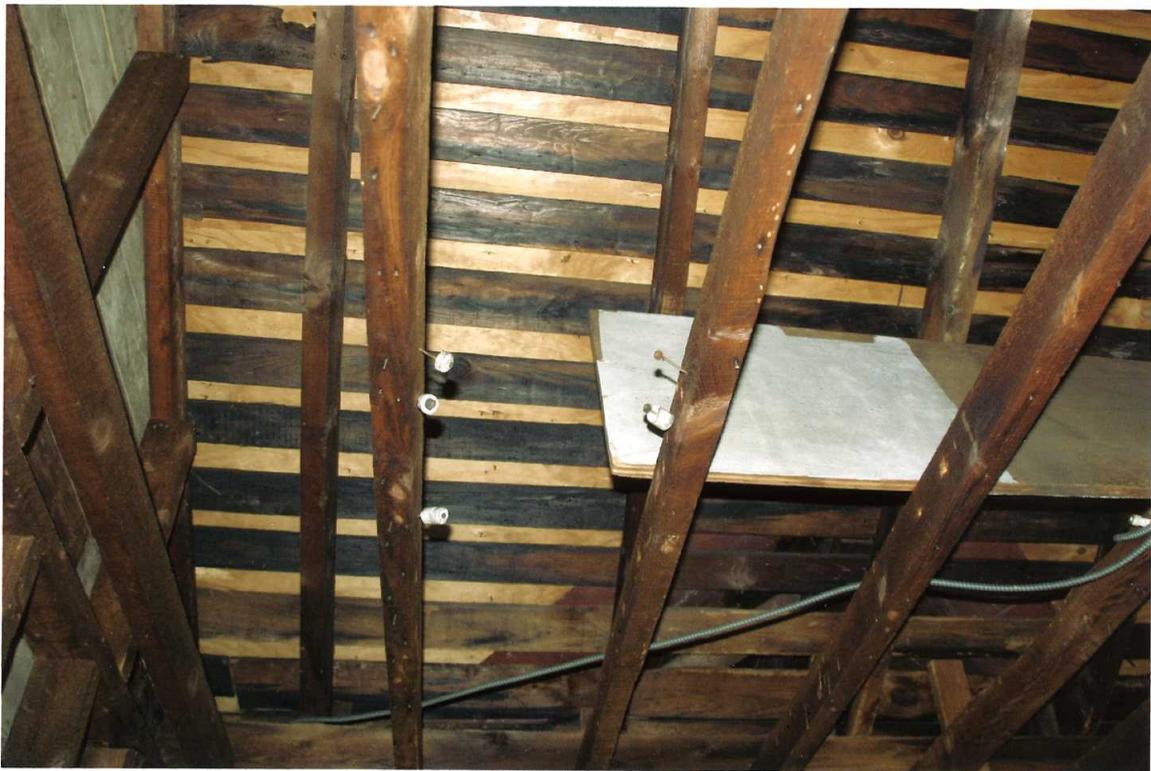
14. Typical roof framing and ceiling joists in Carriage House.
